MATERIALS RESEARCH FOR THE CLEAN UTILIZATION OF COAL

QUARTERLY PROGRESS REPORT

July - September 1980

Center for Materials Science
National Bureau of Standards
U. S. Department of Commerce
Washington, D. C. 20234

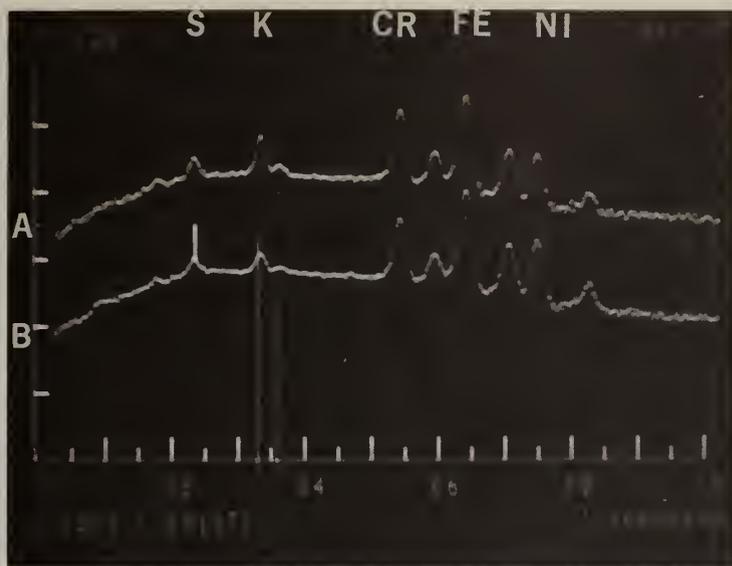
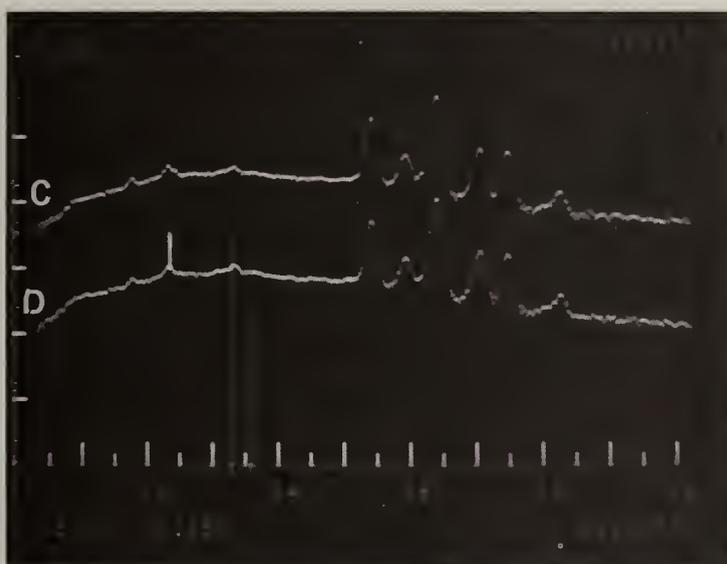
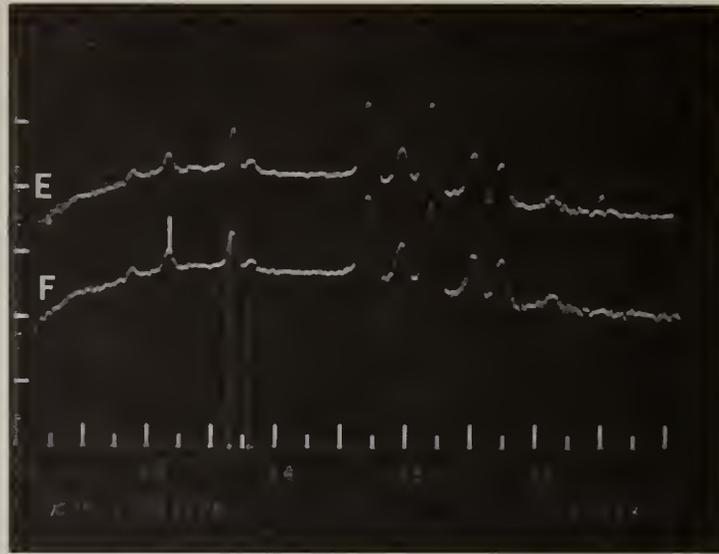
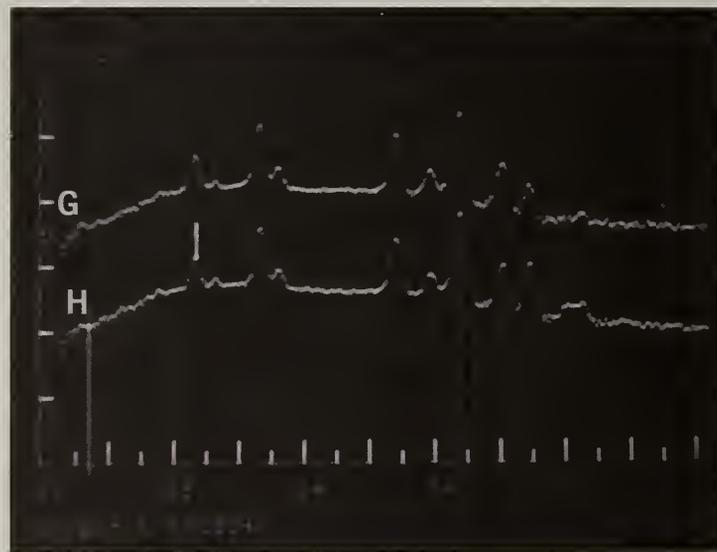
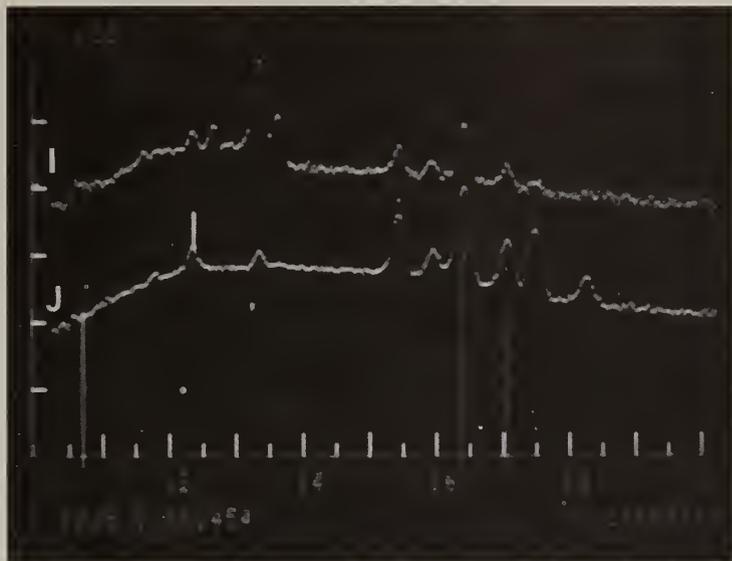
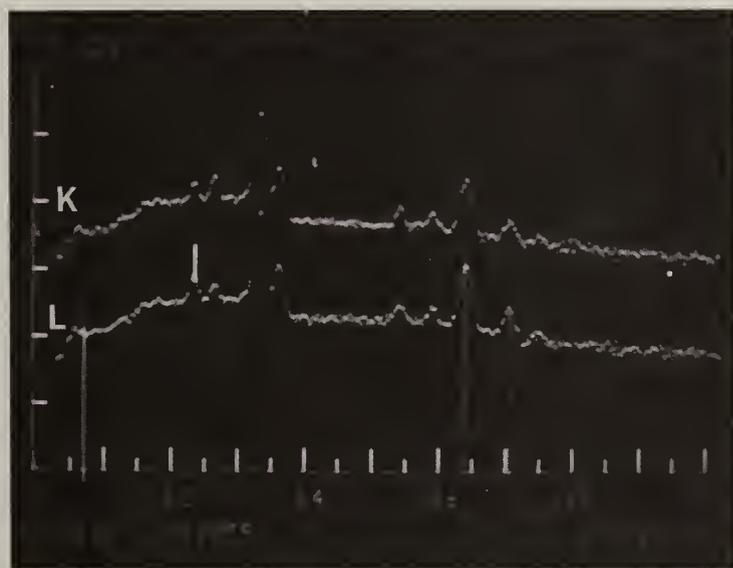
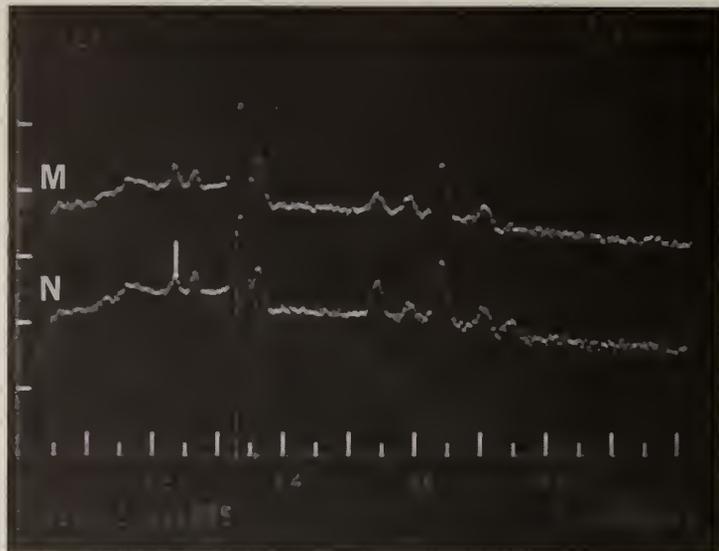
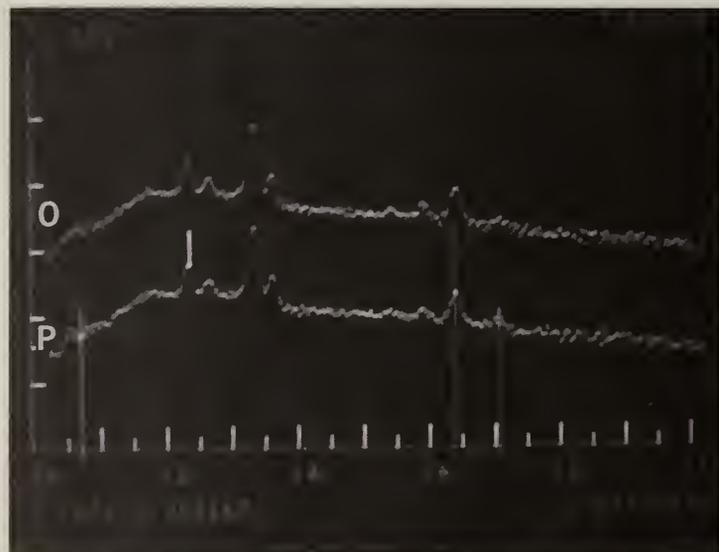
Fig. 5. EDX spectra of regions A and B of Fig. 4 showing slight increase in Ni concentration at metal-reaction zone interface (spectrum B). Specie position and designations of all spectra in this section of the report are as indicated above.

Fig. 6. EDX spectra of regions C and D of Fig. 4 showing bulk spectra.

Fig. 7. EDX spectra of regions E and F of Fig. 4 showing high concentrations of Cr.

Fig. 8. EDX spectra of regions G and H of Fig. 4 showing low concentration of Ni.

Fig. 9. EDX spectra of regions I and J of Fig. 4 showing high concentrations of K.

Fig. 10. EDX spectra of regions K and L of Fig. 4 showing high Fe and K concentrations.

Fig. 11. EDX spectra of regions M and N of Fig. 4 showing high K concentration.

Fig. 12. EDX spectra of regions O and P of Fig. 4 showing Fe and trace Cr in salt deposit.

The corrosion process exhibited in both specimens seem to follow the same general corrosion mechanism. In sample 8-6 (oxygen rich) at the leading edge, salt-stainless interface (Figures 1, 4-12) we find the bulk stainless followed by a reaction zone area where high nickel is found with chromium and iron followed by an area of high chromium, high iron, nickel and potassium. Chromium and iron are then found penetrating the salt deposit with the iron being the most mobile species and moving far into the salt deposit. Nickel being the least mobile or least reactive species is generally not found to penetrate the salt deposit except at the interface where chromium and iron move rather readily through the salt.

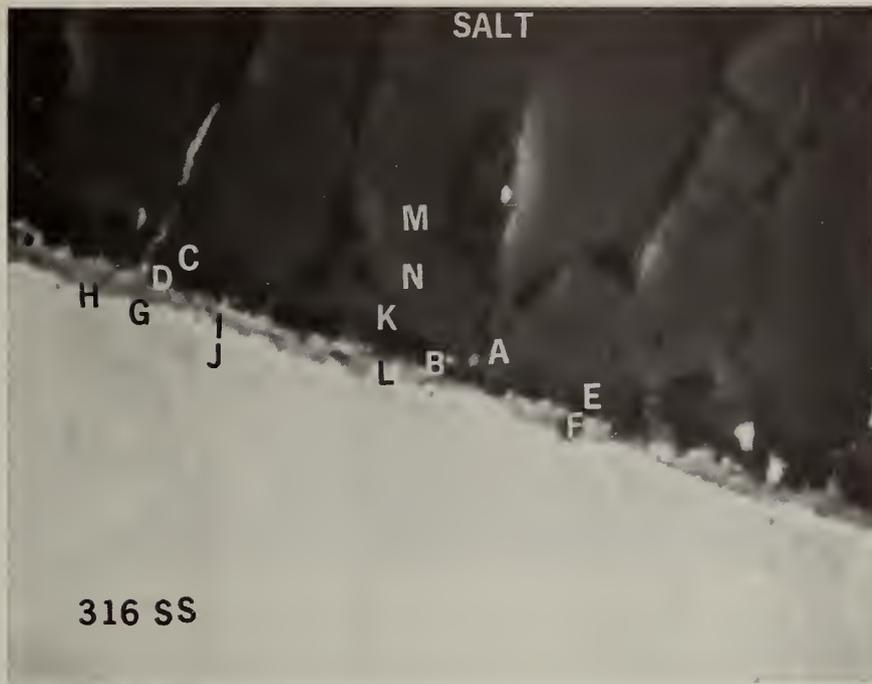
Fig. 13 SEM micrograph, 1800 X, of region T of optical micrograph Fig. 1 showing reaction area at drip zone (fume deposit-salt deposit-metal interface). Lettered regions correspond to labeled EDX spectra, Fig. 14-20.

In 8-6 (Figure 13), the corrosion or reaction zone can be seen at the drip zone salt deposit stainless steel interface region. This darker band region, as analyzed using EDX, Figures 13-20, shows high chromium, iron, low nickel, and potassium, indicating a reacted area on the metal surface. Analysis above and below this region again shows cation mobility. We find concentrations of the cations as follows: a) bulk stainless steel, b) higher nickel-chromium-iron, c) higher chromium-iron-nickel-potassium, d) chromium-high iron-potassium, e) iron-potassium, f) high potassium. Traces of sulfur are found in the coating and reaction areas, also, indicating some sulfur-cation reaction. Therefore, the SEM/EDX analysis seems to indicate a preferential leaching of the metal cations from the bulk materials (Type 316 stainless steel) in a somewhat orderly fashion as in the case of the 304 stainless steel. This can be corroborated by wastage (weight loss) experiments described in previous reports. The chromium and iron cations appear to be the more reactive species in the stainless steel and are preferentially leached by the potassium-sulfur salt. As these cations migrate from the bulk stainless steel composition to the salt deposit the relatively non-reactive nickel is left and what appears as layering is observed.

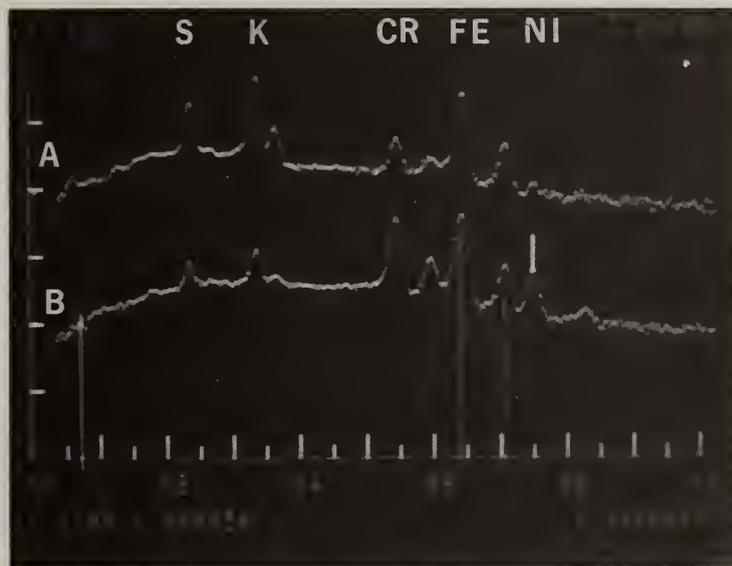
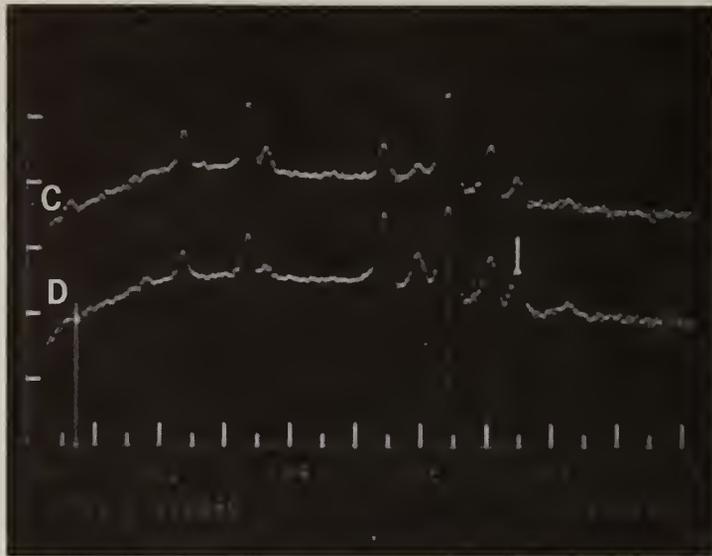
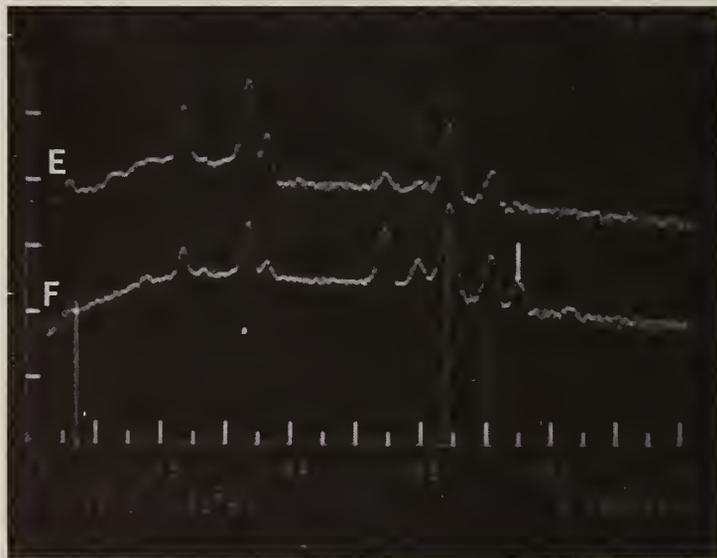
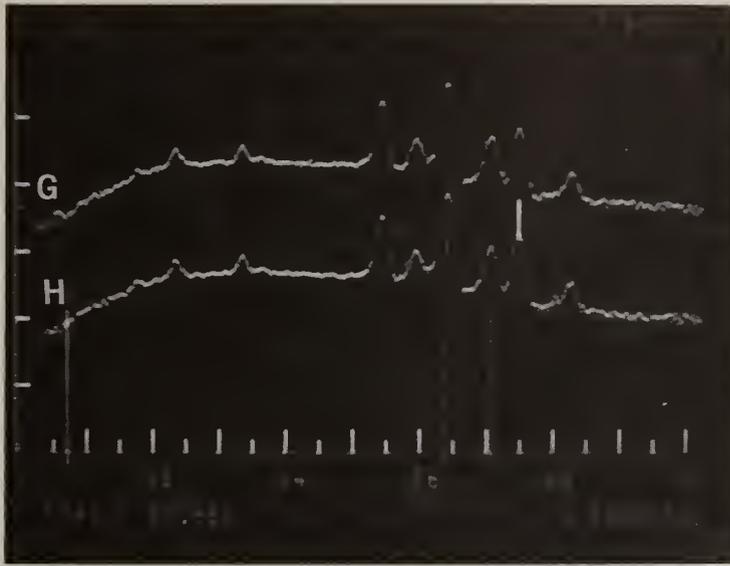
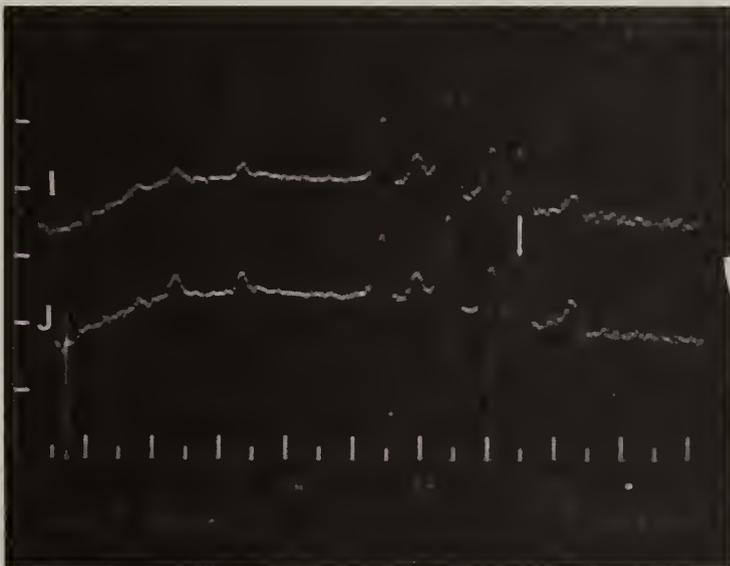
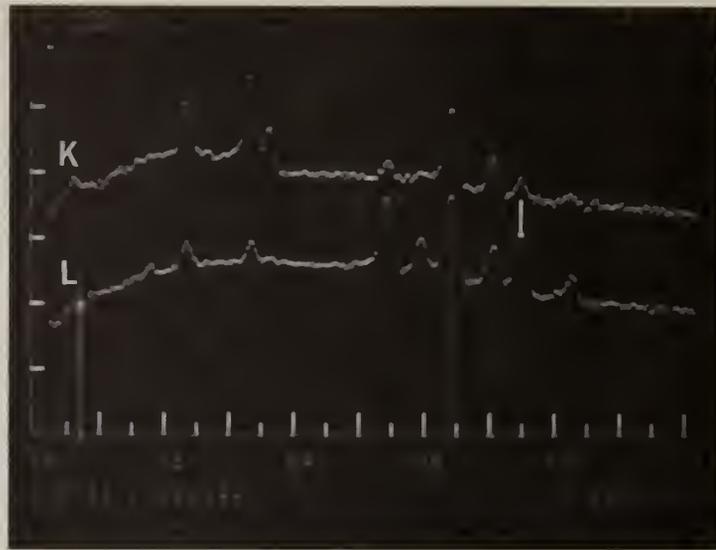
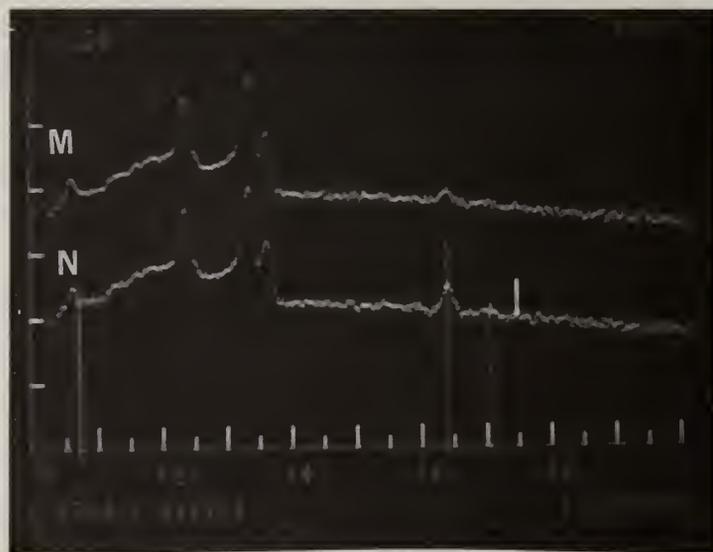
Fig. 14. EDX spectra of regions A and B of Fig. 13 showing high Cr concentration.

Fig. 15. EDX spectra of regions C and D of Fig. 13 showing high Cr concentration.

Fig. 16. EDX spectra of regions E and F of Fig. 13 showing high Cr concentration.

Fig. 17. EDX spectra of regions G and H of Fig. 13 showing high concentrations of both Ni and Cr.

Fig. 18. EDX spectra of regions I and J of Fig. 13 showing high concentrations of both Ni and Cr.

Fig. 19. EDX spectra of regions K and L of Fig. 13 showing high concentrations of both Ni and Cr.

Fig. 20. EDX spectra of regions M and N of Fig. 13 showing high S and K and a trace of Fe.

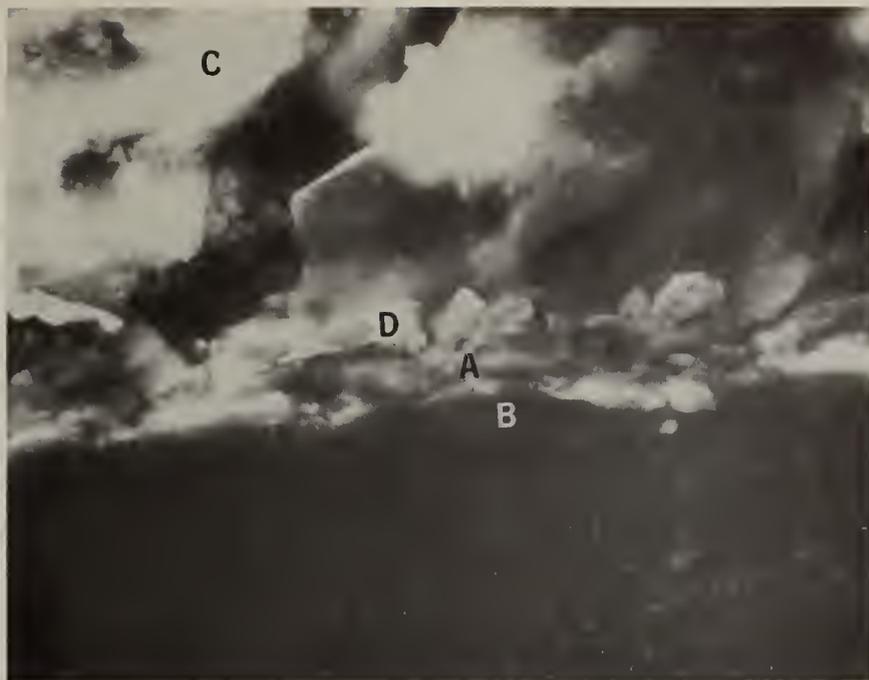
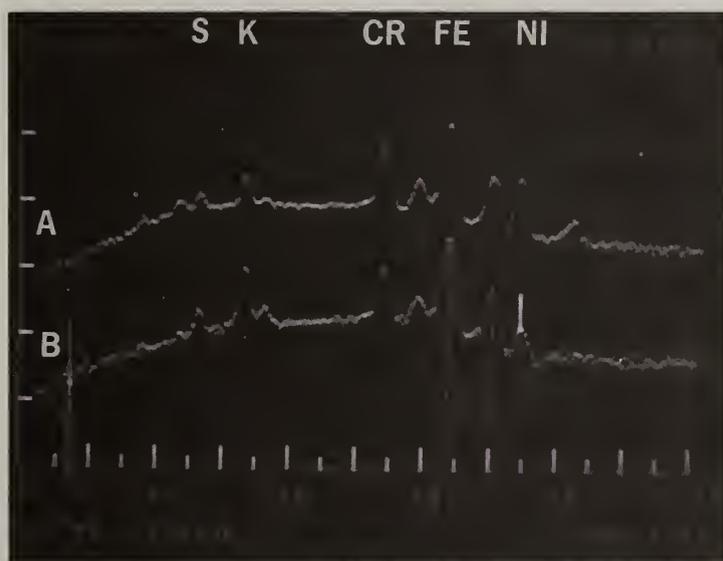
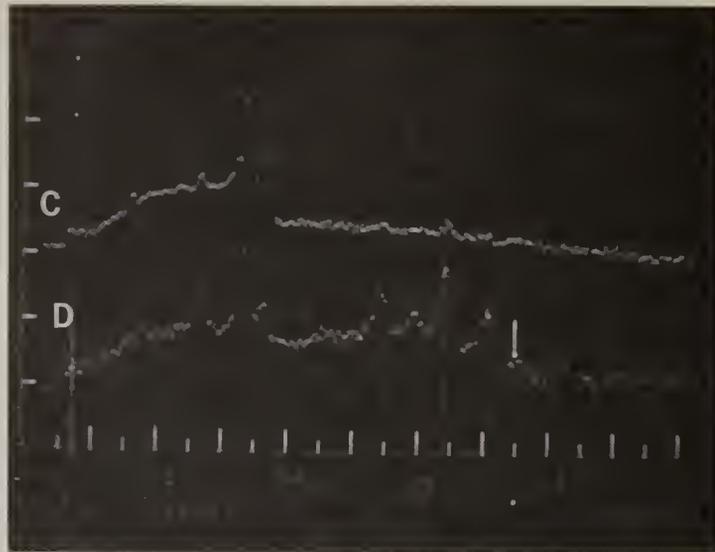
Fig. 21. SEM micrograph, 1800 X, of region γ of optical micrograph Fig. 1 showing reaction area at metal-fume deposit interface. Lettered regions correspond to labeled EDX spectra, Fig. 22 and 23.

Fig. 22. EDX spectra of regions A and B of Fig. 21 showing high Cr concentrations.

Fig. 23. EDX spectra of regions C and D of Fig. 21 showing absence of Ni.

Figures 21-23 shows a portion of the fume deposit region where the corrosive process appears to be evident. On the edge, areas of low nickel are found, while areas of chromium, iron, potassium, and sulfur are found in the reaction zone. However, in the fume deposit region there is not as great a separation of the cations, as found by EDX, possibly due to the fact that no direct contact of the salt is made in this area during deposit but rather collected on the underside by condensation from the vapor.

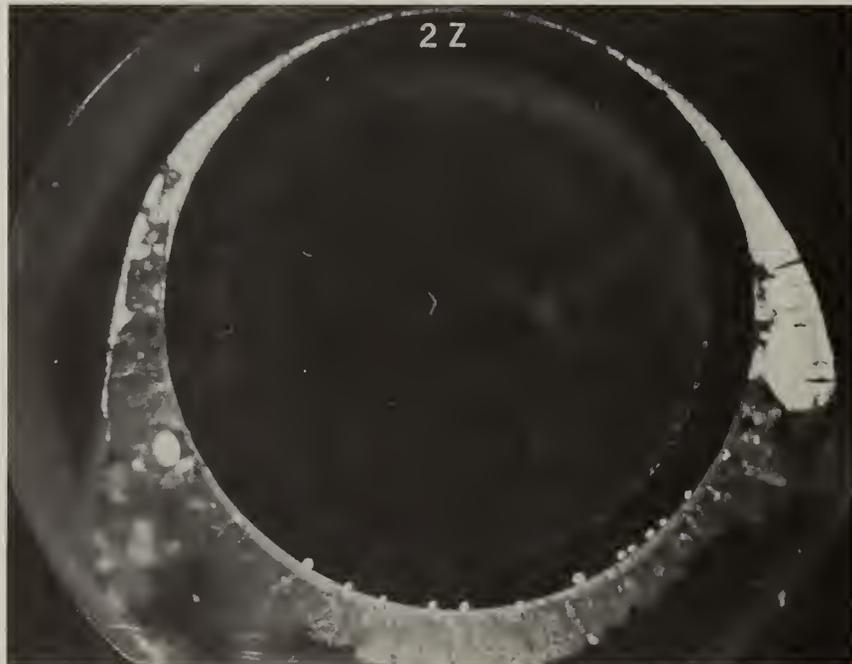
Fig. 24. Optical micrograph of a section of Type 316 stainless steel tubing after exposure to a fuel rich hot gas stream seeded with K_2SO_4 and K_2CO_3 . Tube temperature $590^\circ C$. Note deposit on upper surface of tube.

An evaluation of specimens 8-6 (Figure 1) and 9-6 (Figure 24) can be made simultaneously. Both samples were seeded with 80% by weight K_2CO_3 and 20% by weight K_2SO_4 , with wall temperatures of 590 °C, however, 8-6 was in an oxygen rich fuel environment and 9-6 was in a fuel rich environment. The variations in the salt deposit can readily be observed with the oxygen rich specimen (8-6) exhibiting a top deposit of 0.3 mm, drip deposit of 2 mm and a slight fume deposit. The fuel rich specimen (9-6) shows a top coating of 0.1 mm, drip deposit of 1.6 mm and a very unusual fume deposit region, dendritic in nature. Photos (Figures 2 and 3) show a banding property in the deposit with K + S near the surface of the steel followed by a high K region with a thin band of K + S on the surface. This phenomenon is also seen in the

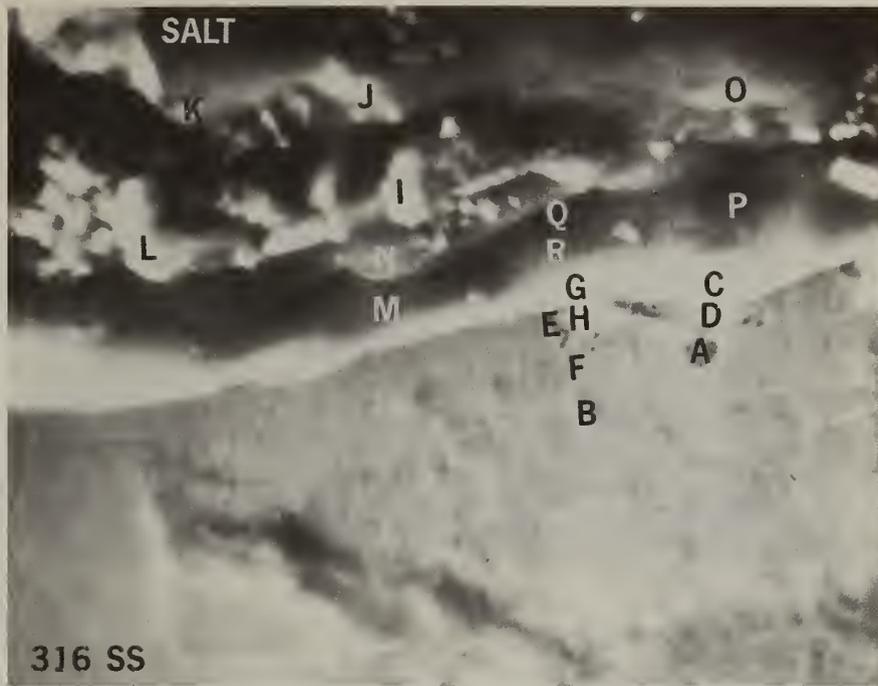
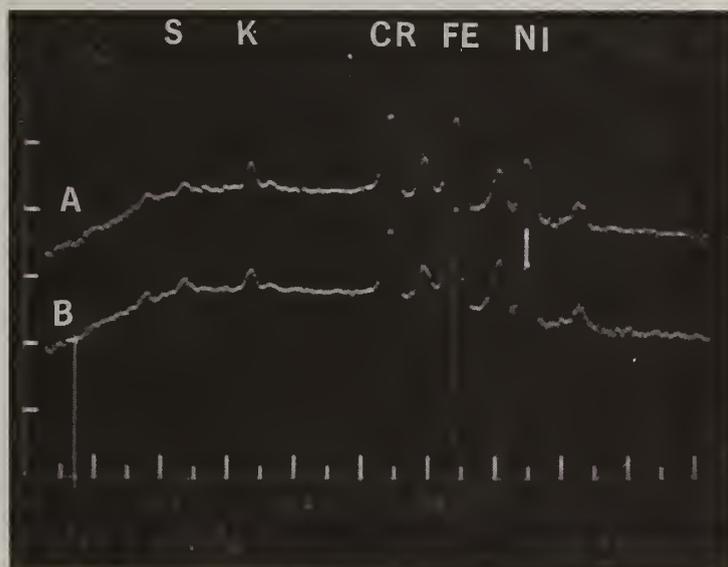
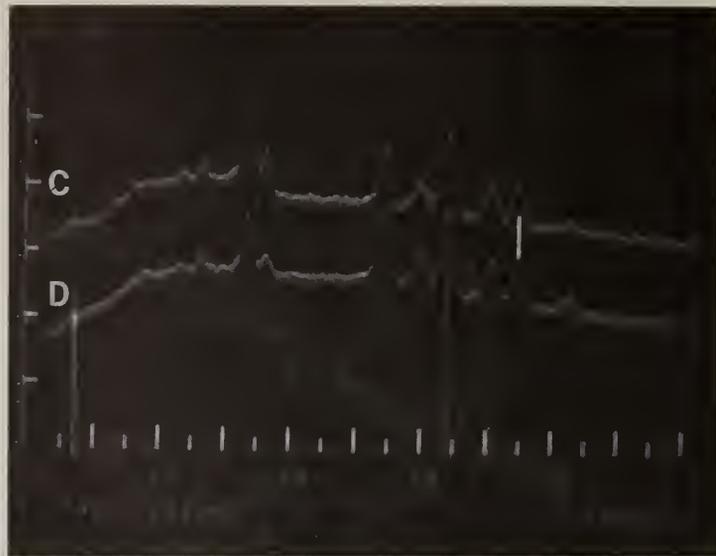
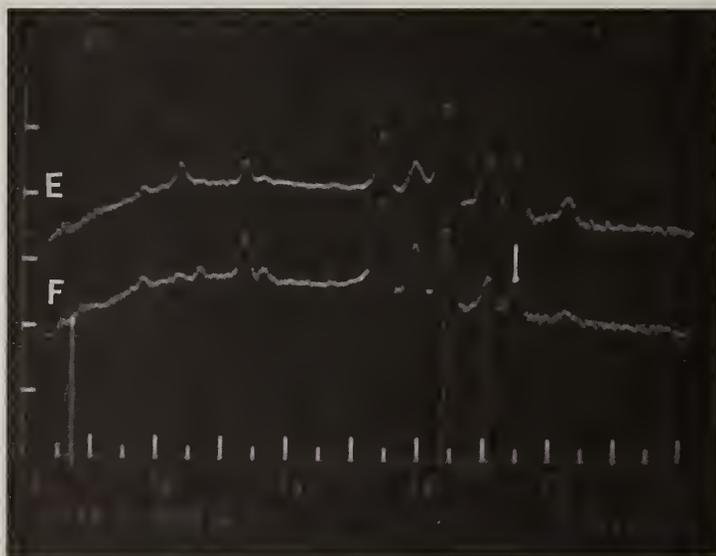
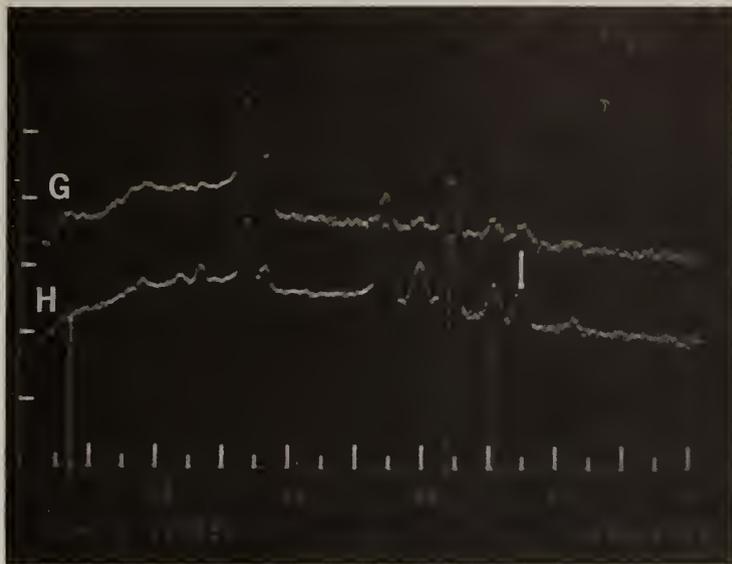
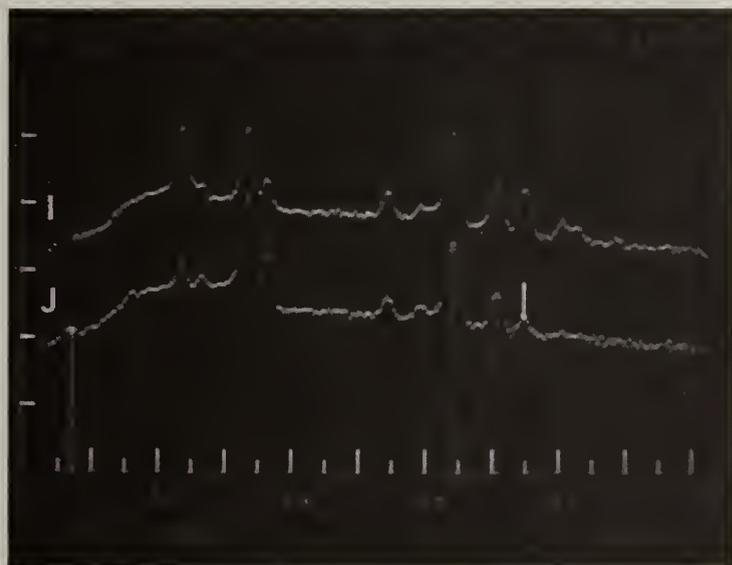
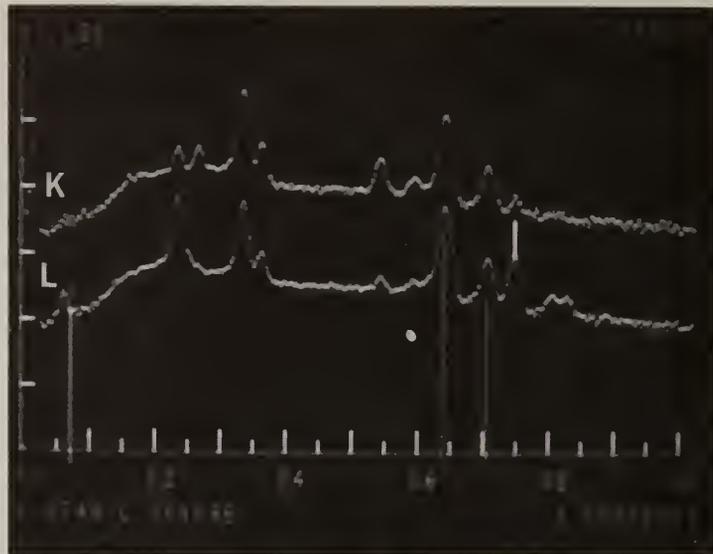
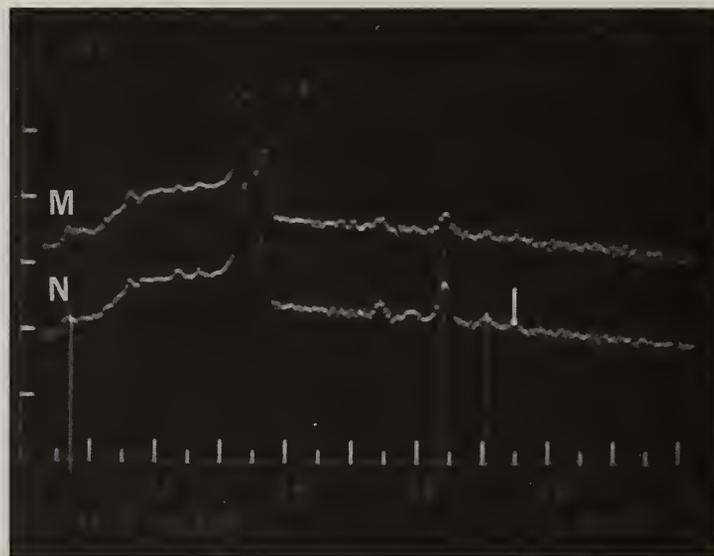
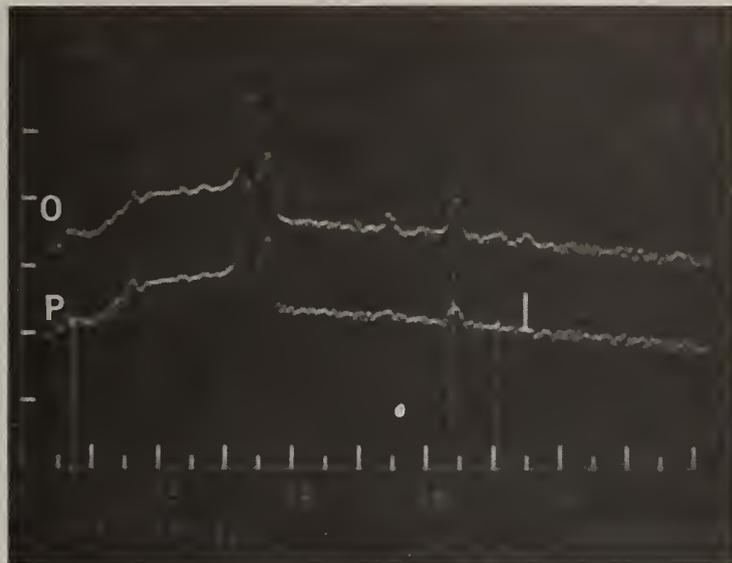
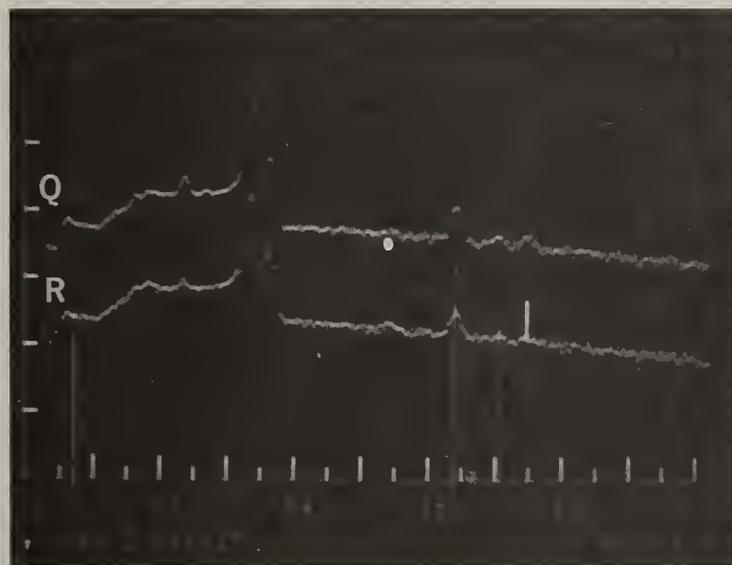
Fig. 25. SEM micrograph, 1720 X, of region 2Z of optical micrograph Fig. 24. Lettered regions correspond to labeled EDX spectra Fig. 26-34.

Fig. 26. EDX spectra of regions A and B of Fig. 25 showing high Cr and Ni concentrations.

Fig. 27. EDX spectra of regions C and D of Fig. 25 showing high Cr and Ni concentrations.

Fig. 28. EDX spectra of regions E and F of Fig. 25 showing high Cr concentrations.

Fig. 29. EDX spectra of regions G and H of Fig. 25 showing high Cr concentrations.

Fig. 30. EDX spectra of regions I and J of Fig. 25 showing high Fe concentrations.

Fig. 31. EDX spectra of regions K and L of Fig. 25 showing high Fe concentrations.

Fig. 32. EDX spectra of regions M and N of Fig. 25 showing Fe.

Fig. 33. EDX spectra of regions O and P of Fig. 25 showing trace of Fe in the salt deposit.

Fig. 34. EDX spectra of regions Q and R of Fig. 25 showing trace of Fe in the salt deposit.

In sample 9-6, fuel rich, at the leading edge of the stainless steel (Figures 24-34) we again find the bulk stainless steel followed by a reaction zone area. As in the fuel rich sample (8-6), what appears to be a distinctive corrosion banding appears using EDX analysis. The corrosive process in the oxygen rich fuel environment

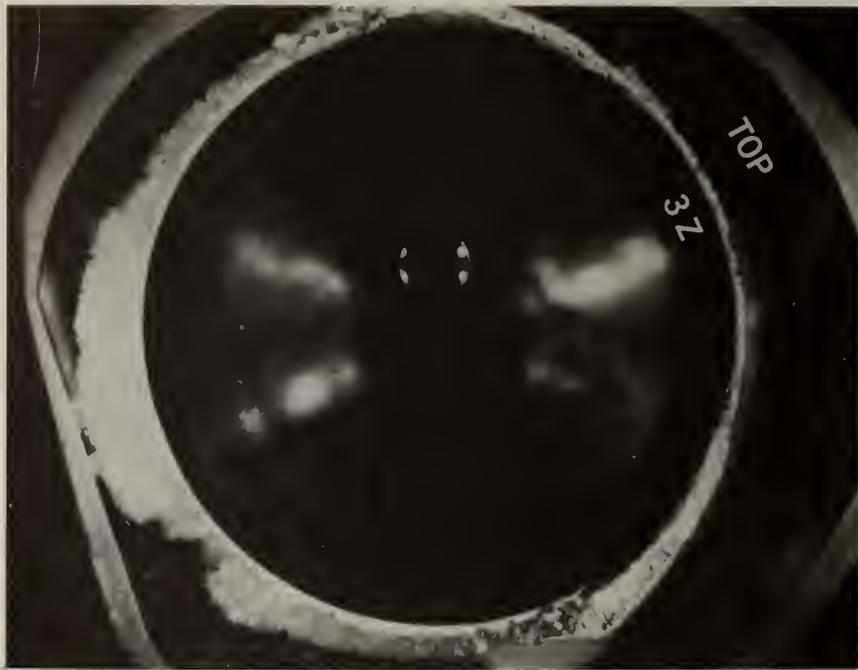
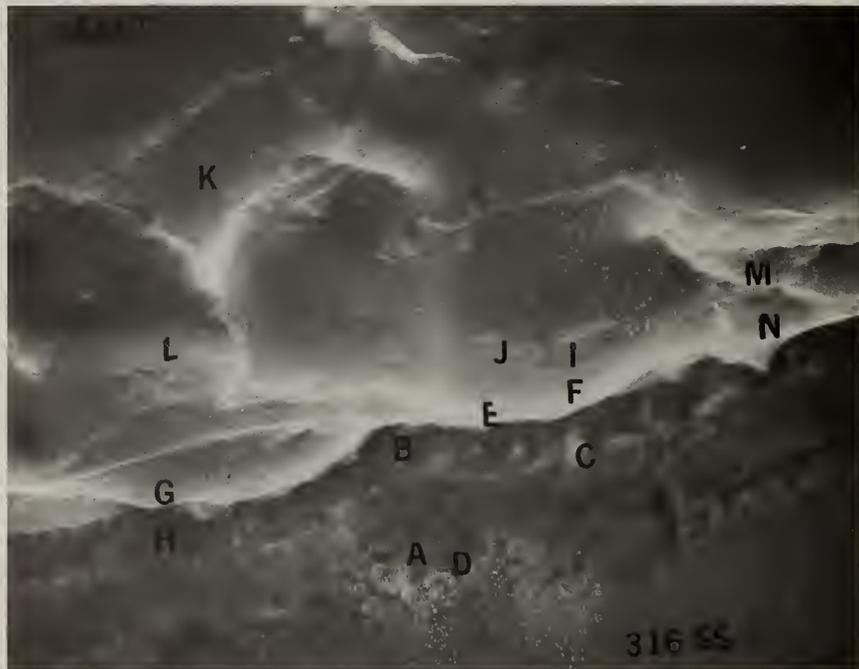
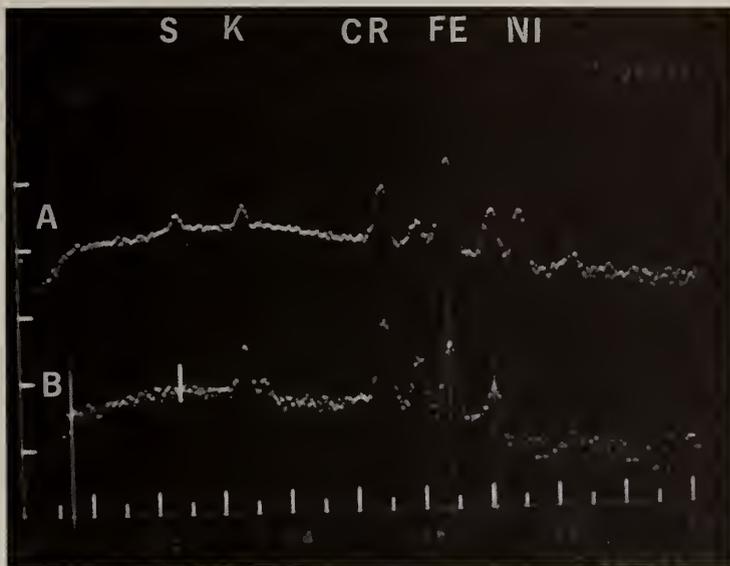
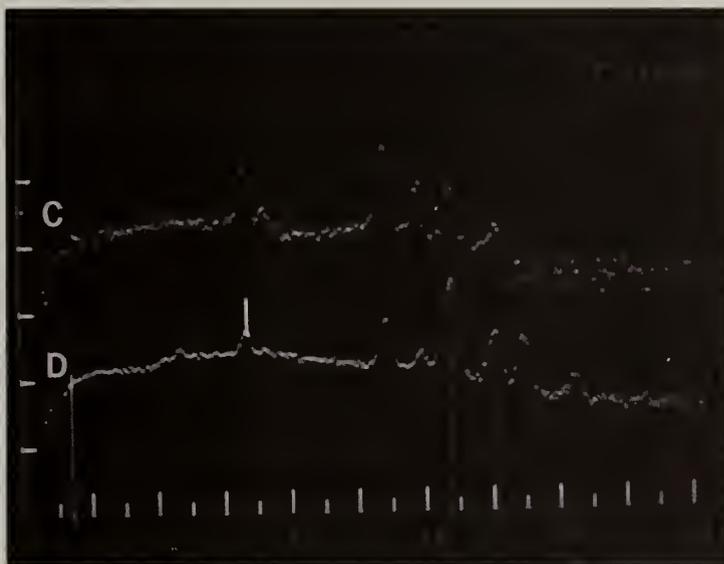
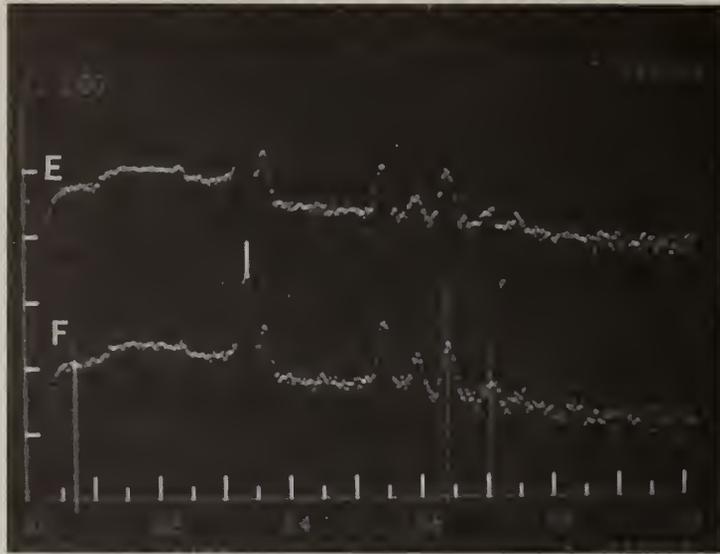
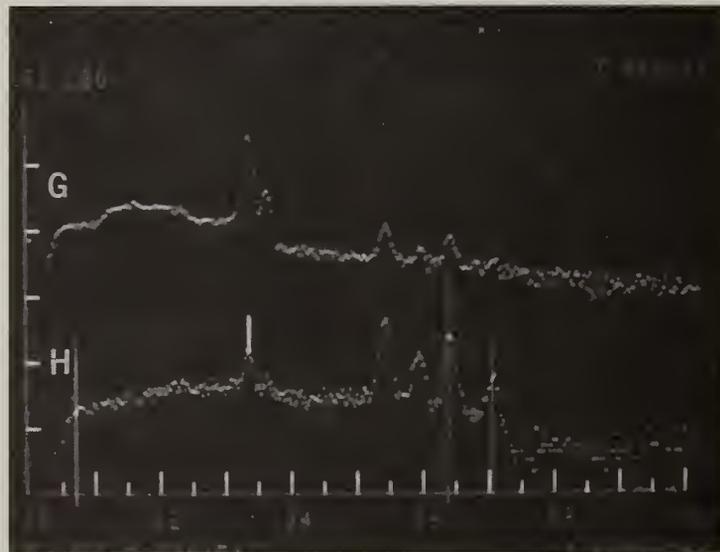
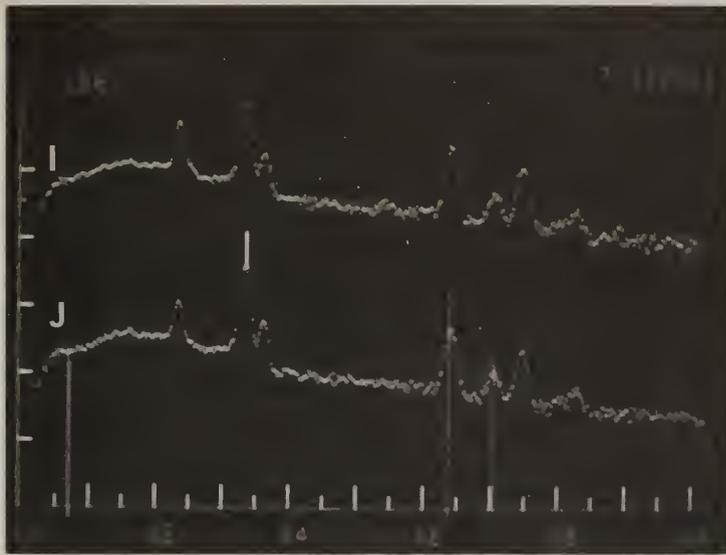
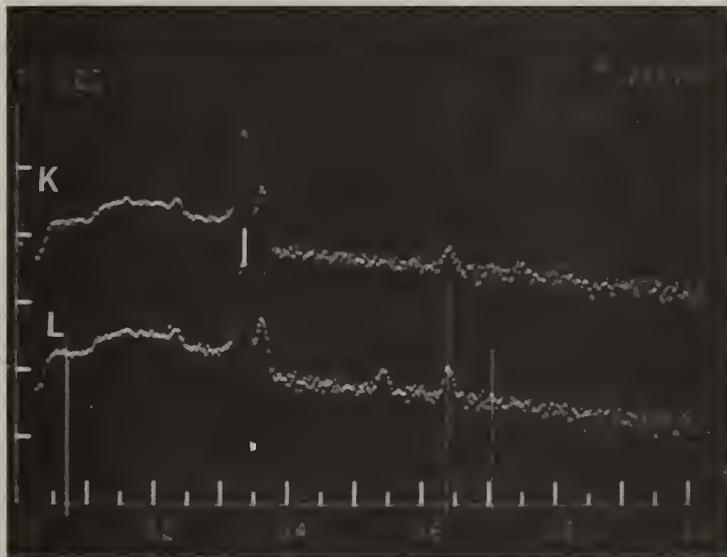
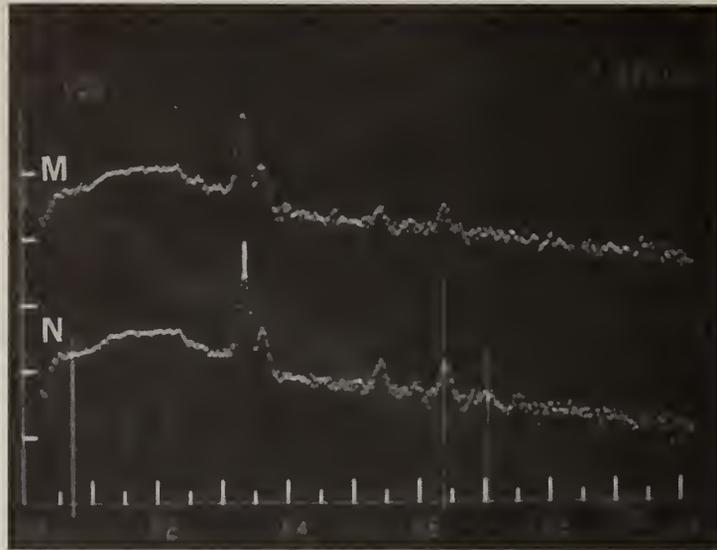
Fig. 35. Optical micrograph of a section of Type 316 stainless steel tubing after exposure to a fuel rich hot gas stream seeded with K_2SO_4 . Tube wall temperature $590^\circ C$. Note deposit on upper surface of tube.

Fig. 36. SEM micrograph, 1720 X, of region 3Z of optical micrograph, Fig. 35. Lettered regions correspond to labeled EDX spectra Fig. 37-43.

Fig. 37. EDX spectra of regions A and B of Fig. 36 showing high concentrations of Cr and absence of Ni.

Fig. 38. EDX spectra of regions C and D of Fig. 36 showing high concentrations of Cr and absence of Ni.

Fig. 39. EDX spectra of regions E and F of Fig. 36 showing high concentrations of Cr and absence of Ni.

Fig. 40. EDX spectra of regions G and H of Fig. 36 showing high concentrations of Cr and absence of Ni.

Fig. 41. EDX spectra of regions I and J of Fig. 36 showing high concentrations of Ni and absence of Cr.

Fig. 42. EDX spectra of regions K and L of Fig. 36 showing high concentrations of K with a trace of Fe and Cr.

Fig. 43. EDX spectra of regions M and N of Fig. 36 showing high concentrations of K with a trace of Fe and Cr.

The reaction zone area in 6-6 (Figures 35-43) is not well delineated in the fuel rich system as compared to the oxygen rich system, however, corrosion is observed. SEM/EDX analysis indicated that the reaction bands above the stainless steel bulk composition have the following sequence: a) low chromium-nickel-iron, b) high chromium-iron-no nickel, c) chromium-iron-potassium, d) high potassium-chromium-iron, e) high potassium-iron, f) high potassium. Traces of sulfur are associated with the potassium but the bulk of the salt coating is high in potassium. As found in previous specimens, nickel is absent in high concentration. At the interface no nickel is detected whether this be through loss of the nickel or its displacement to other areas not readily detectable is not apparent. However, the migration of chromium to the edge of the stainless steel is seen with iron and chromium penetrating the salt deposits. Examination of the drip deposit region show similar results as previously discussed with the absence or near absence of nickel at the metals edge, and with chromium and iron moving into the salt layer region. The fume deposit region showed minimal corrosion while the coating contained high potassium.

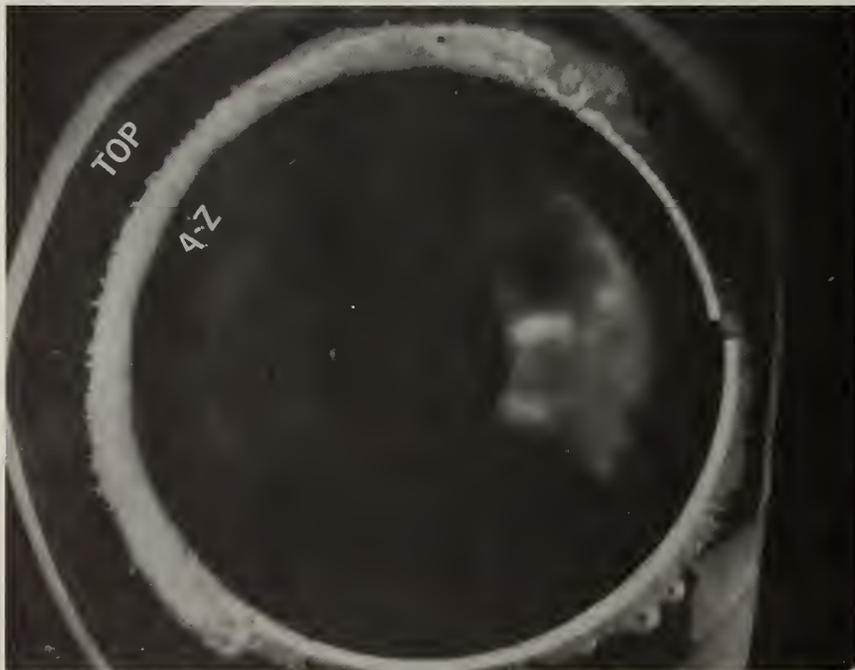
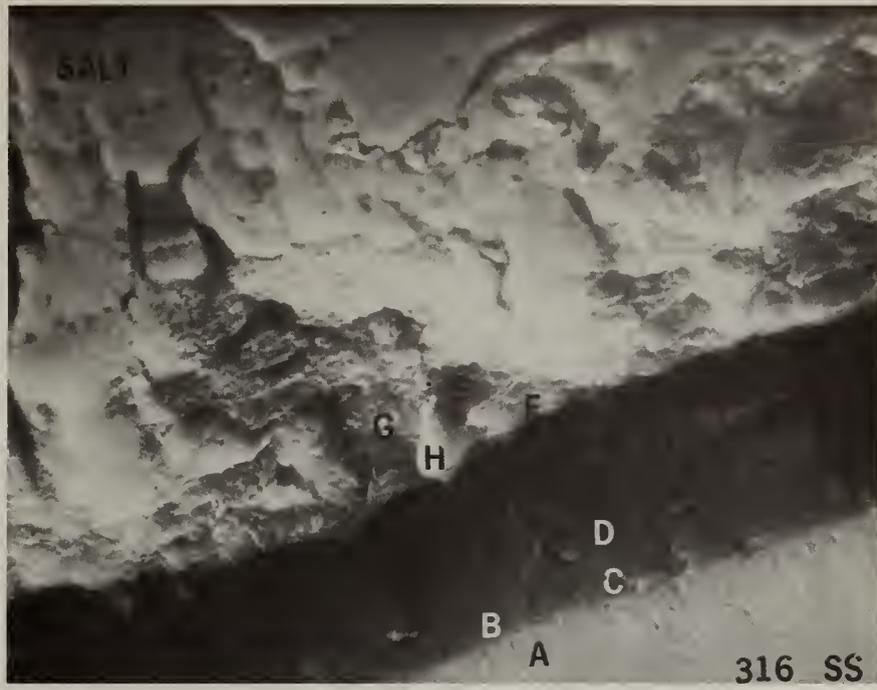
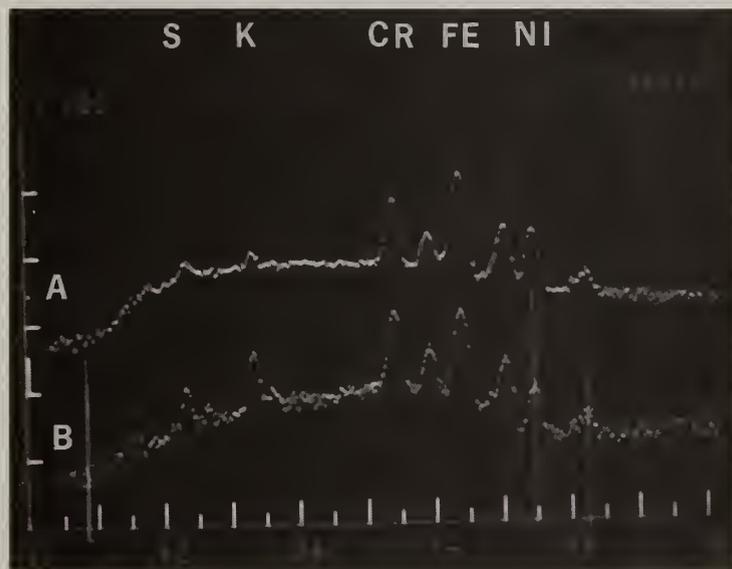
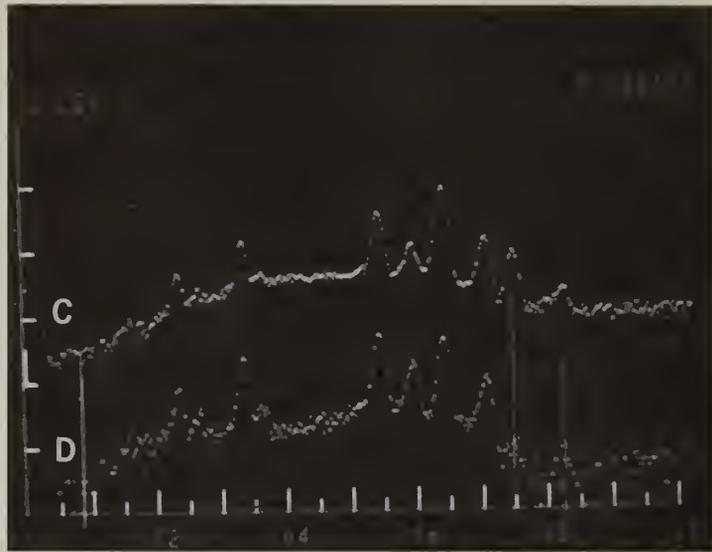
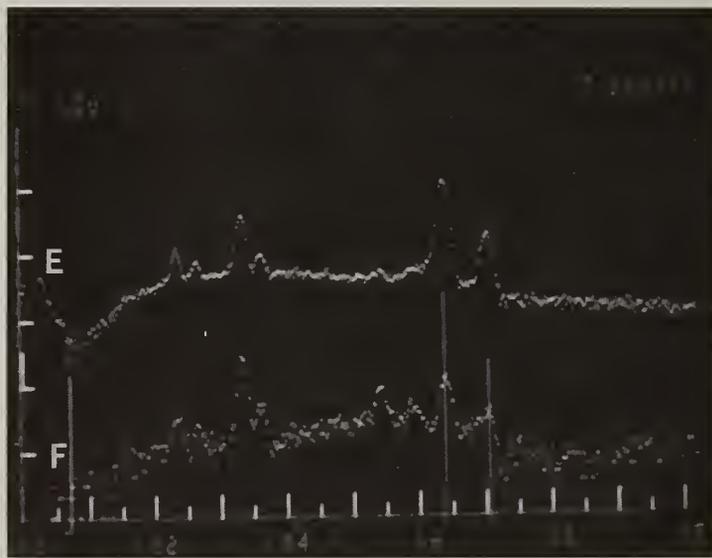
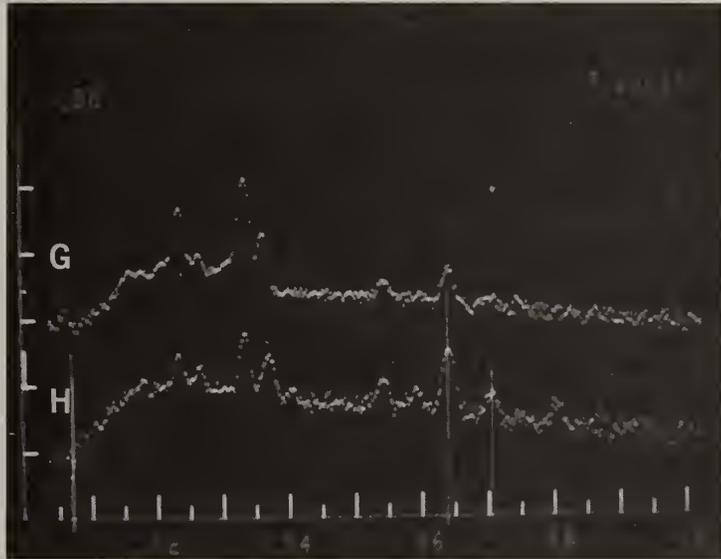
Fig. 44. Optical micrograph of a section of Type 316 stainless steel tubing after exposure to a fuel rich hot gas stream seeded with K_2SO_4 . Tube wall temperature $500^\circ C$. Note deposit on upper surface of tube.

Fig. 45. SEM micrograph, 1160 X, of region 4Z of optical micrograph Fig. 44 showing reaction area at metal-salt interface. Lettered regions correspond to labeled EDX spectra Fig. 46-49.

Fig. 46. EDX spectra of regions A and B of Fig. 45 showing high Cr and low Ni concentrations.

Fig. 47. EDX spectra of regions C and D of Fig. 45 showing high Cr and no Ni.

Fig. 48. EDX spectra of regions E and F of Fig. 45 showing high concentrations of Fe with a slight trace of Cr.

Fig. 49. EDX spectra of regions G and H of Fig. 45 showing Fe with a trace of Cr.

At a lower temperature of 500 °C, corrosion is still observed in Type 316 stainless steel, 5-6, using K_2SO_4 salt in a fuel rich environment. Figures 44-49 shows the reaction zone area at the metal-salt interface at the leading edge. In this area we find, using SEM/EDX: a) bulk stainless steel, b) low nickel-high chromium-iron-potassium-sulfur, c) potassium-iron-chromium-sulfur, d) potassium-iron-sulfur, e) potassium-sulfur. An area of high nickel is not detected while areas of high chromium and iron are readily discernible in the reaction zone. This corrosion mechanism is also found in the drip zone area and the fume deposit region, though both to a lesser degree.
